The
San Francisco Earthquake and Fire

A BRIEF HISTORY OF THE DISASTER

A Presentation of Facts and Resulting Phenomena, with Special
Reference to the Efficiency of Building Materials
Lessons of the Disaster

A. L. A. HIMMELWRIGHT, C.E.

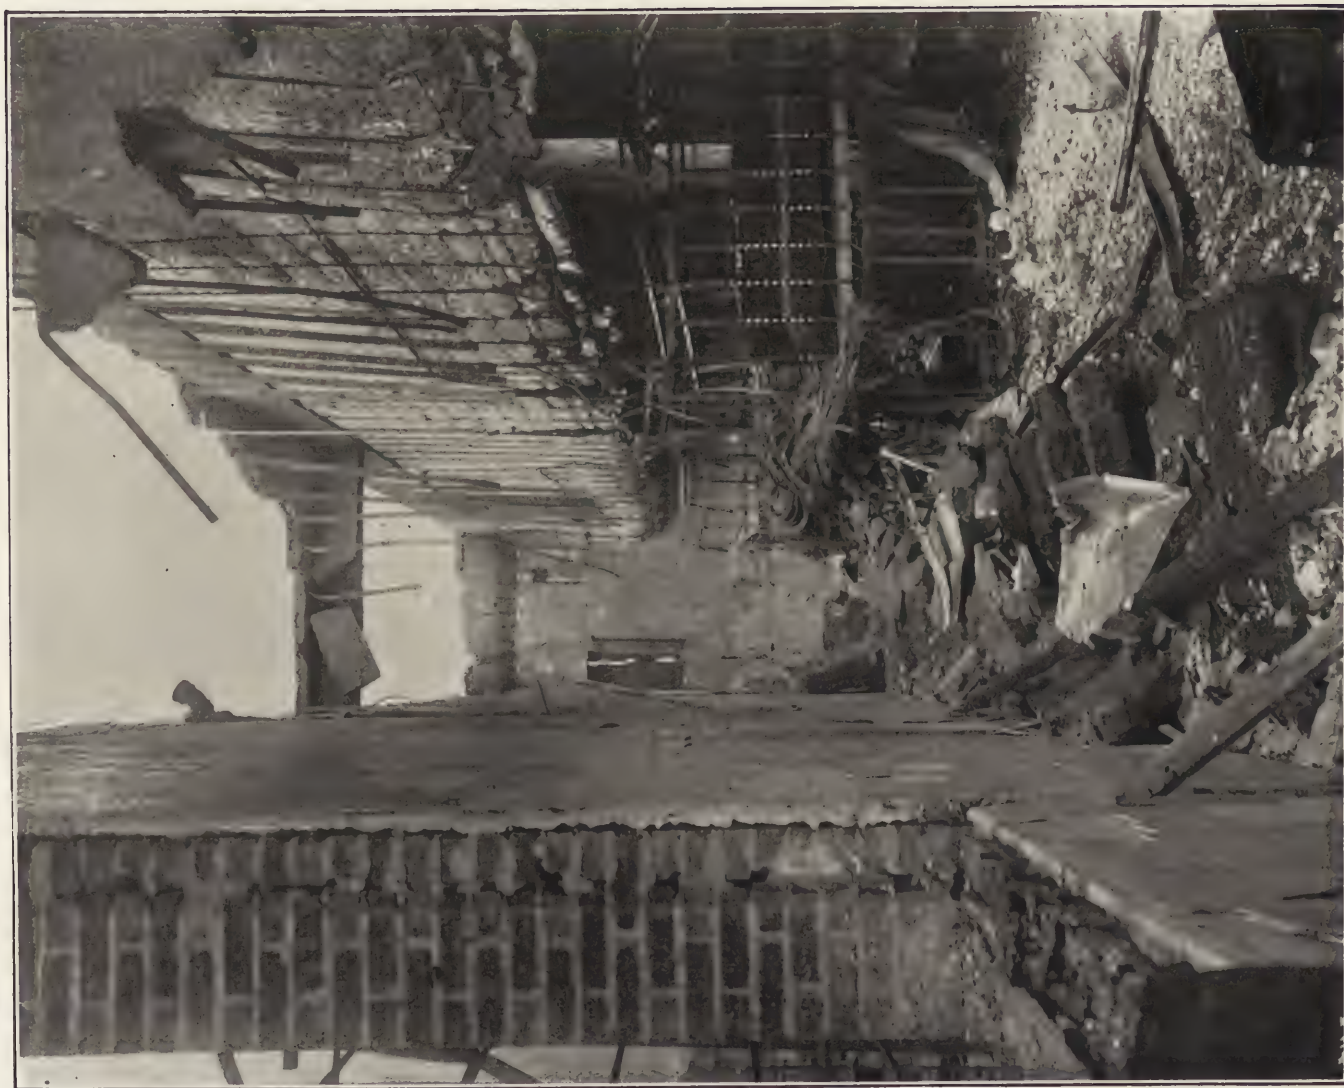
PACIFIC STATES TEL. & TEL. CO.'S South Office. Third Story. Showing earthquake cracks in the rear wall causing the wall on the left side to move outward. The roof arch adjoining, unsupported, fell into the building to the third floor. The ceiling construction with plaster is hanging to the beam at the right hand side. Part of the burned switchboard is shown in the foreground. The exterior wall wire furring and plaster remain on the rear and left hand walls.

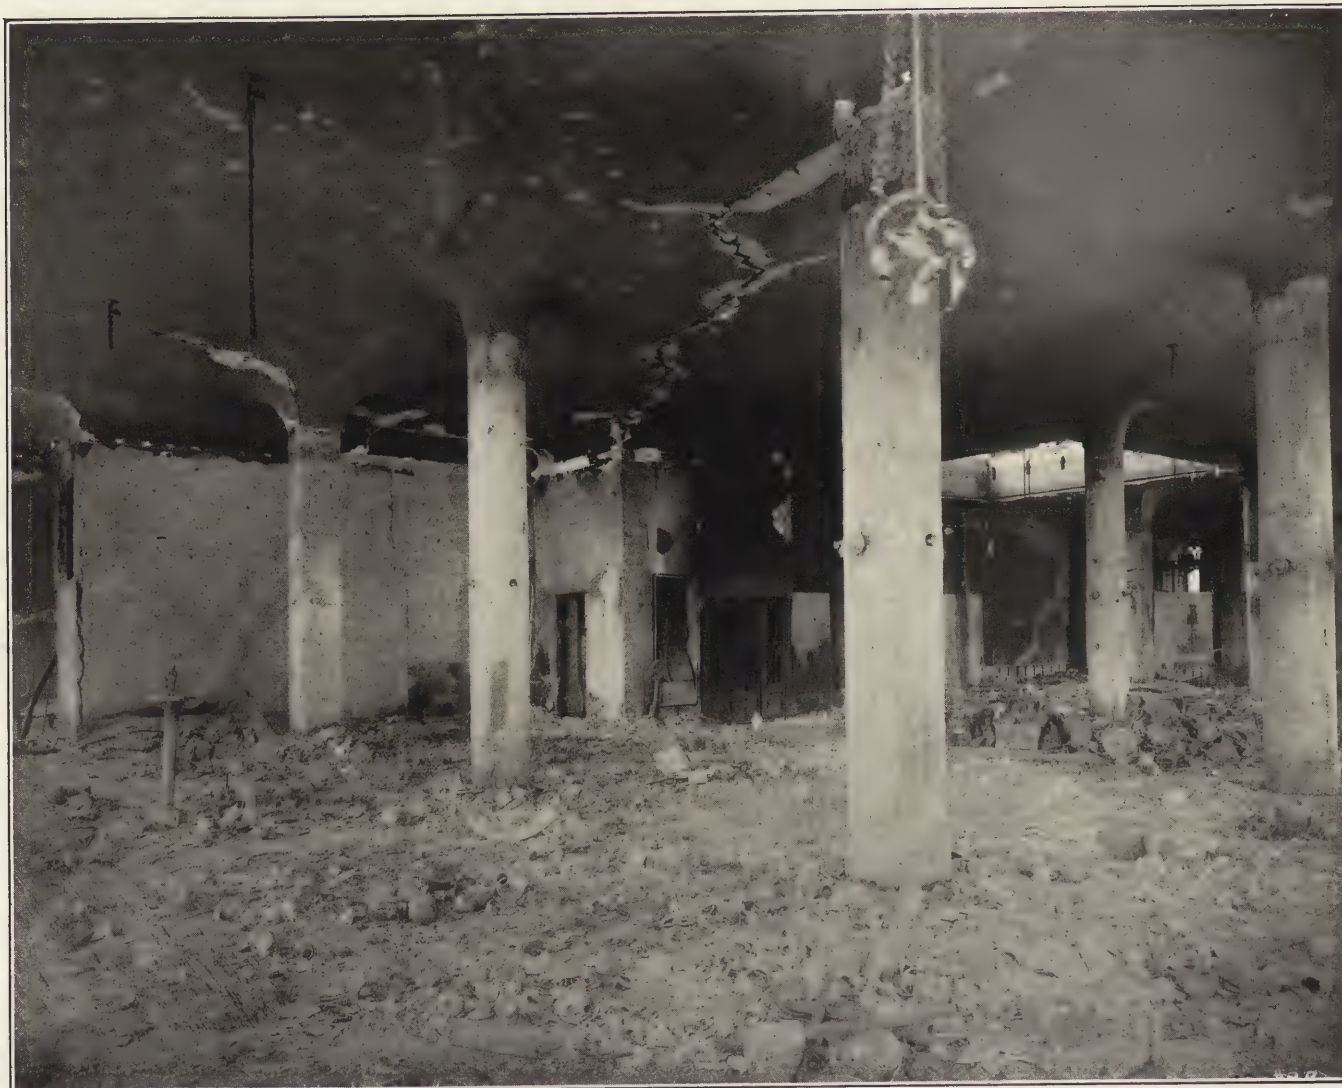
SHREVE BUILDING. Second Story. Typical view showing the condition of the Roebling concrete floors, wire lath and plaster ceilings, concrete column protection and 4" solid concrete and plaster partitions in the rear. The erratic crack in the plastered ceiling in the centre, and the cracks in the concrete partition, were caused by the earthquake.

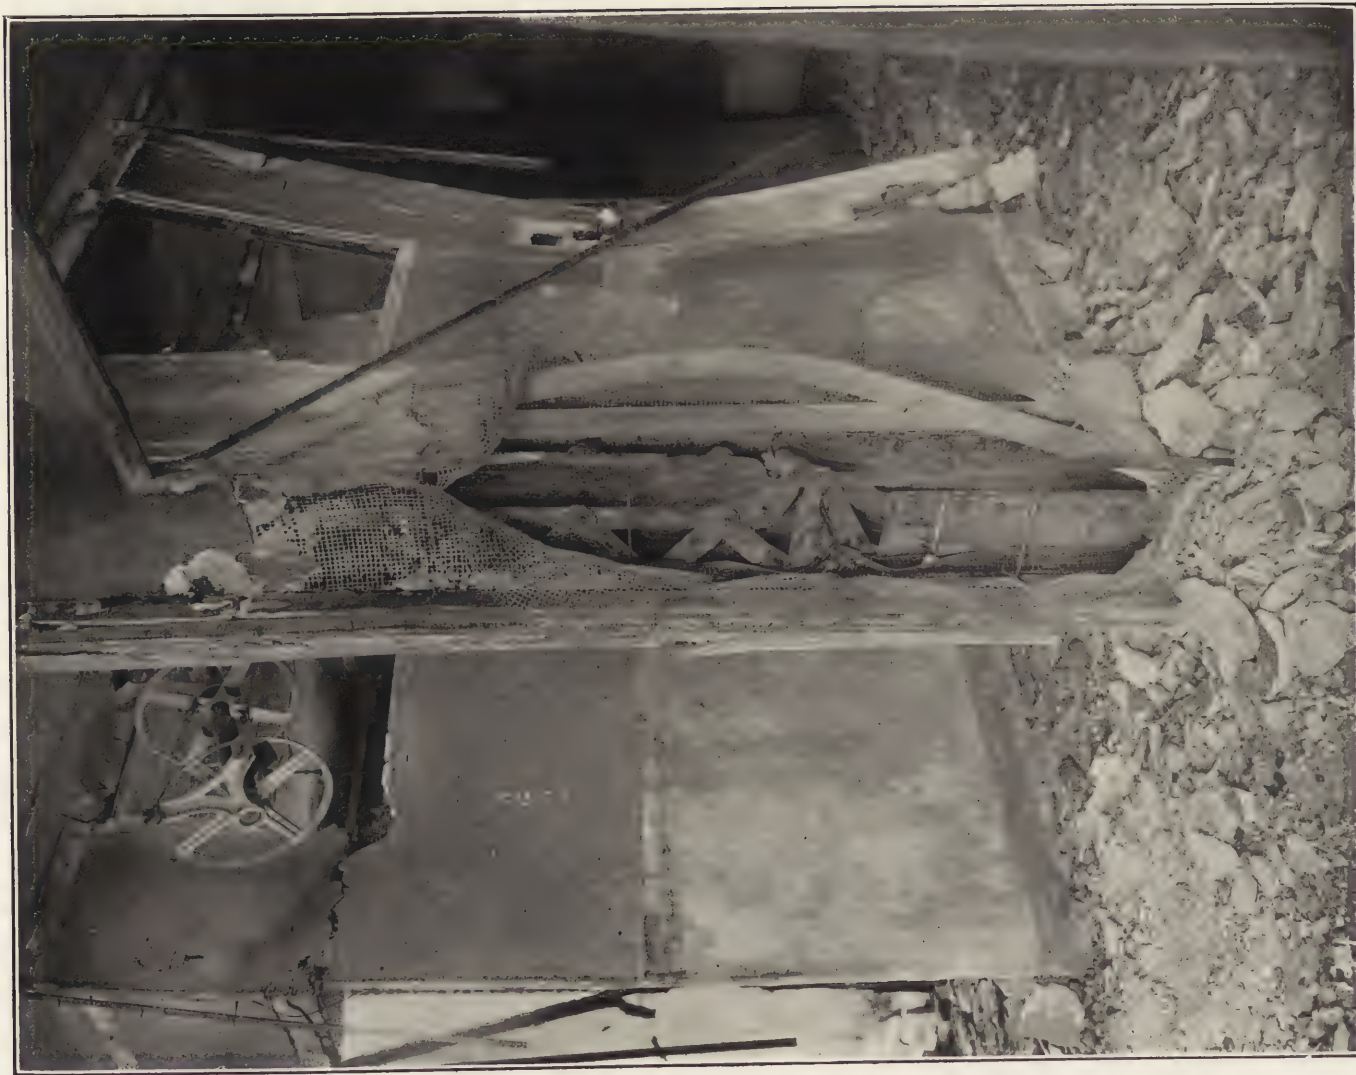
HOTEL HAMILTON. Twelfth Story. Showing a buckled column and the flimsy manner in which it was protected. Only a few light rods were used for the furring and these did not anchor the protection to the column. Note the deflection of the partition due to the settling of the column.

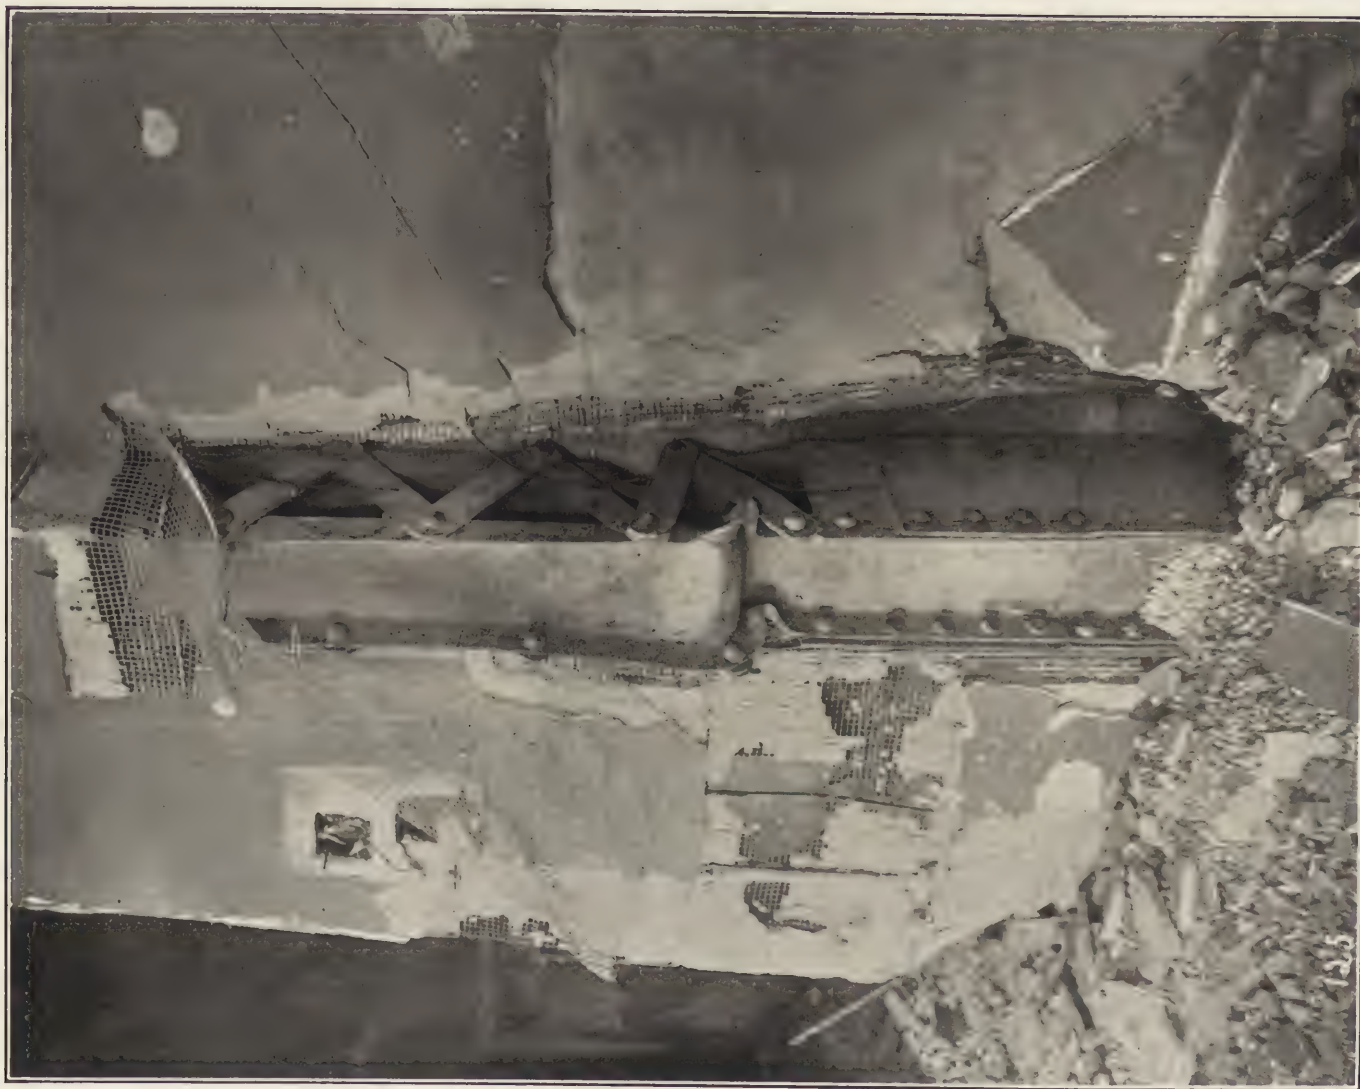
HOTEL HAMILTON. Twelfth Story. Showing the failure of the wire lath and plaster column protection, and the buckling of the partitions due to the settling of the column. The failure of the column protection was caused by the inadequate furring, the lath being simply bent to a rectangular form around the column and attached to the partition in line with the column. Occasionally a $\frac{1}{4}$ " round rod was used as a support for the lath bracketted from the partitions. In no case was the column protection anchored rigidly to the column.

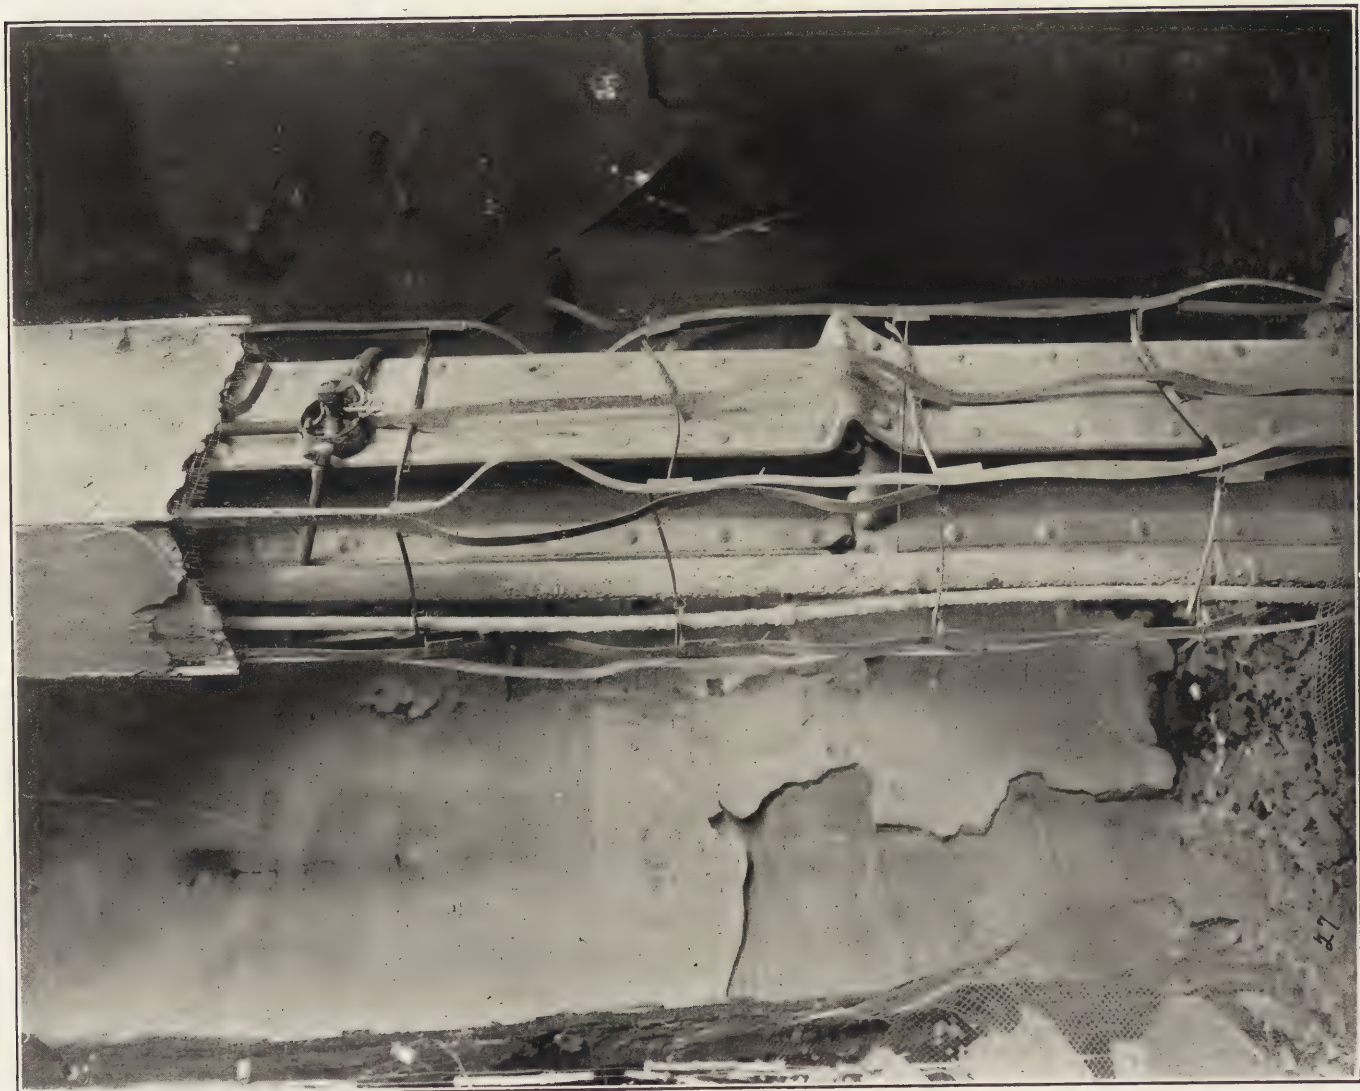
HOTEL ALEXANDER. Buckled column showing the typical method of the furring and lathing for column protection in this building. The light metal furring consisted of No. 16 gauge sheet steel, slotted by the Collins method. Note the excessive buckling and destruction of the furring when such light metal is used for this purpose.

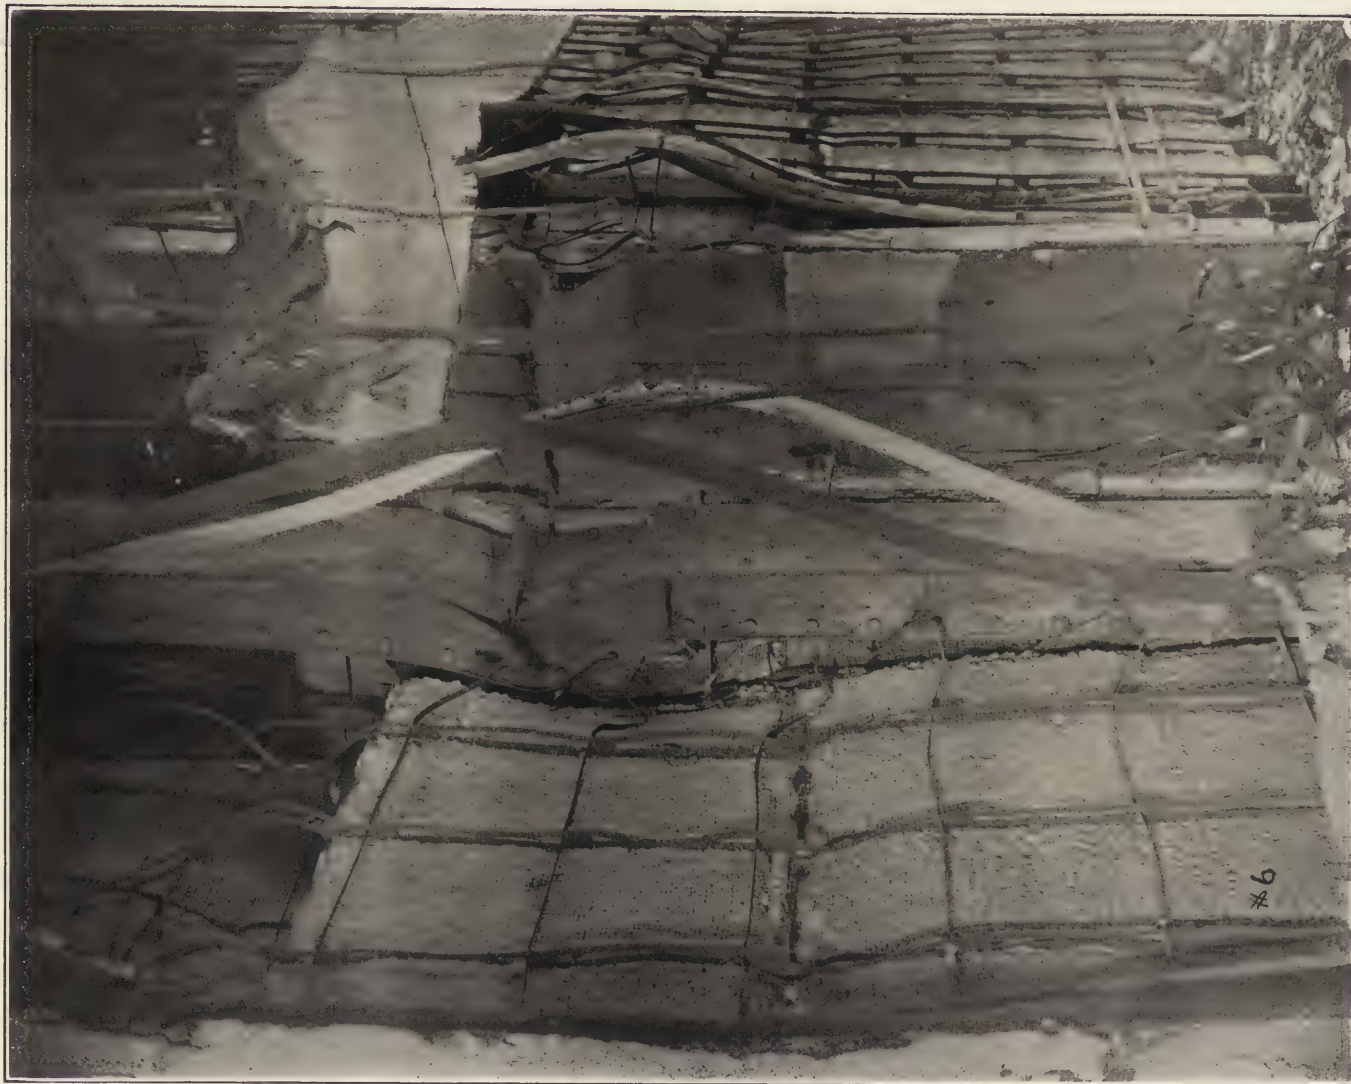
HOTEL ALEXANDER. A buckled column caused by insufficient protection. In many cases the wire lath and plaster partitions enclosing a large blind space around the column were the only fire-proof protection provided. The studs for the partitions in this building were of No. 16 sheet metal, $2\frac{1}{2}$ inches wide, of the Collins slotted metal type. Note the excessive buckling of the light sheet metal due to the heat. The bulging of the pipes adjacent to the column probably contributed to the damage.

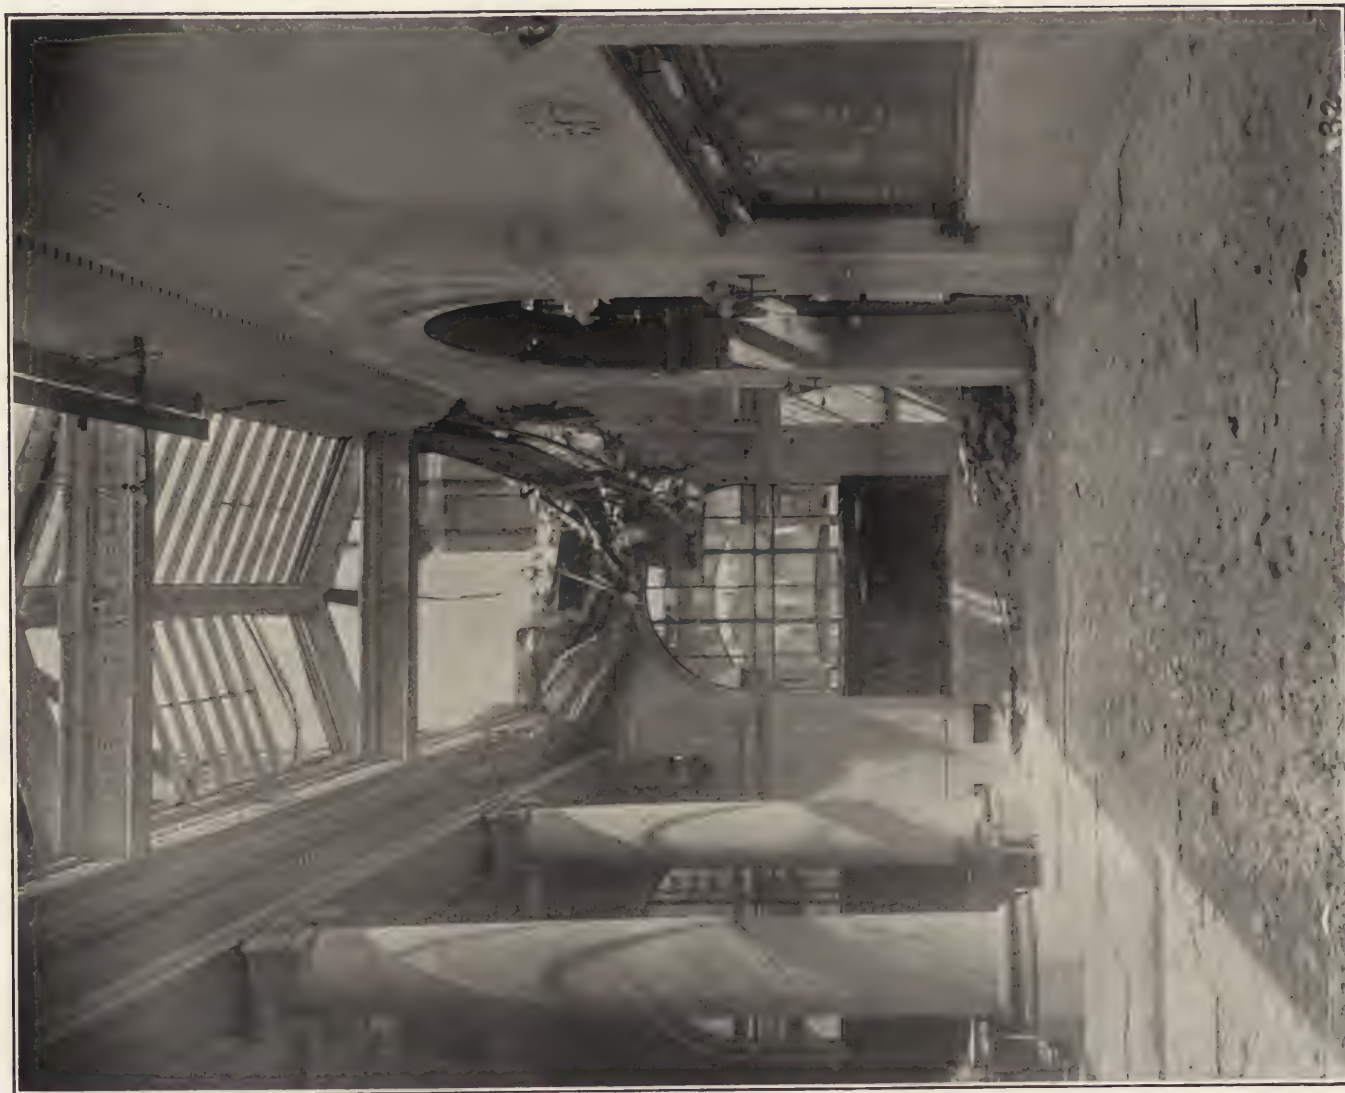
MERCHANTS' EXCHANGE BUILDING. Showing the damage to the exchange room by the earthquake. A section of a six-story building on the opposite side of Luedsdorff Street fell across the street on the roof and skylight of this corner of the room, carrying with it two vaults. One of these fell into the exchange room, and can be seen on the floor at the left hand side. The other is lodged on the roof near the corner of the building amongst other *débris*. Excepting this injury, the exchange room has sustained but little damage.

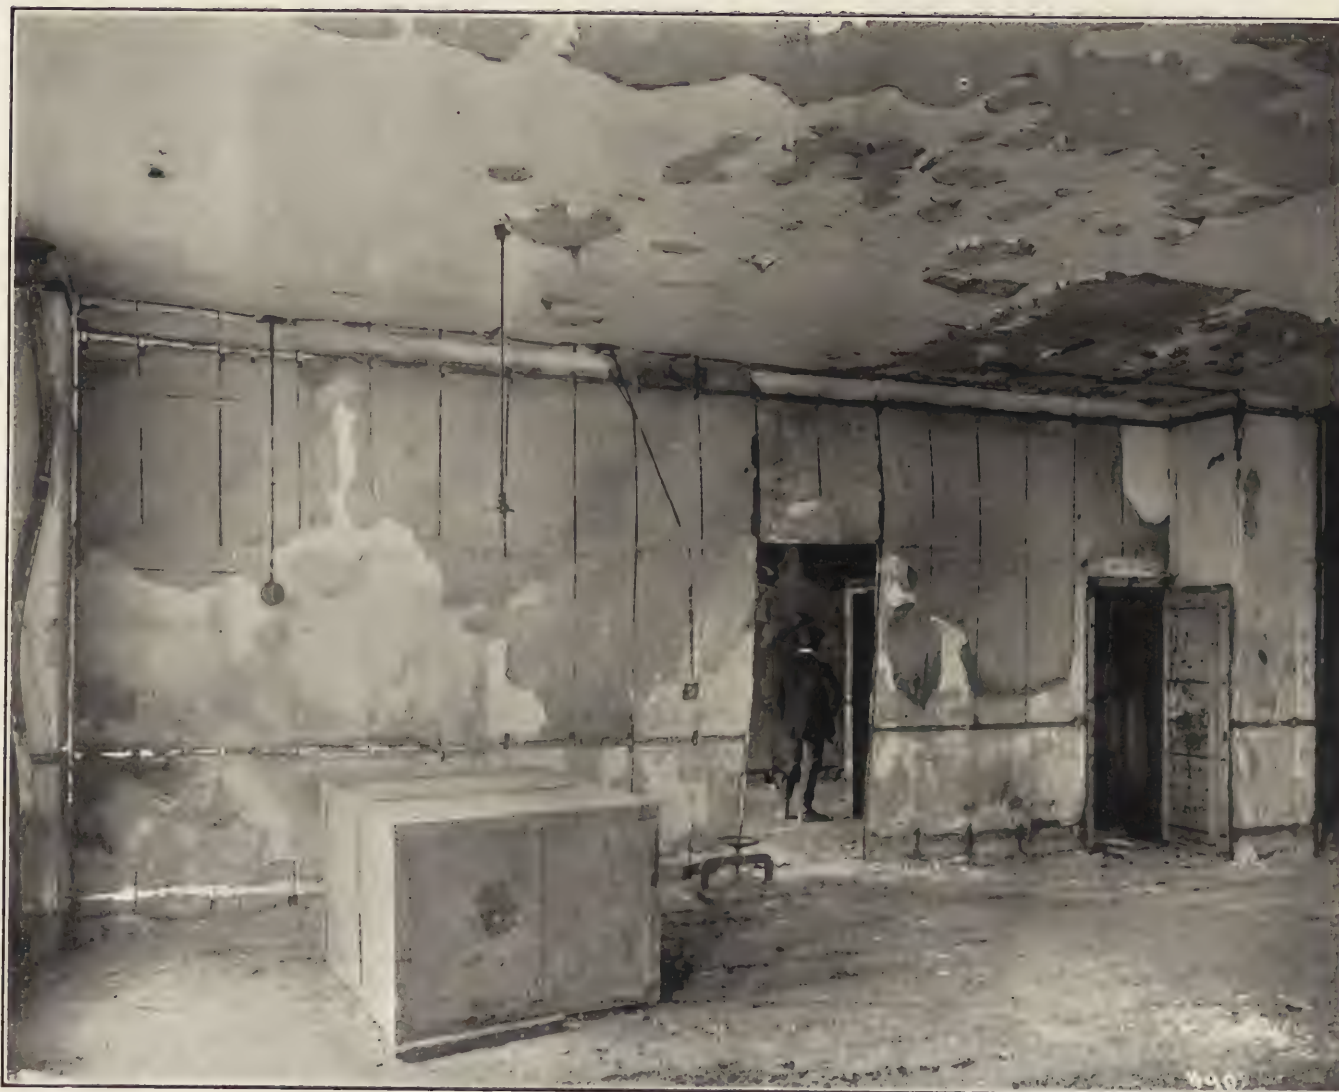
MERCHANTS' EXCHANGE BUILDING. Typical view showing the condition of the wire lath and plaster ceilings and partitions. The safe in the foreground fell over on its side without doing any damage to the Roebling concrete floor. The vault on the right, enclosed by a solid wire lath and plaster partition 2" thick, preserved its contents. The contents of a number of other similar vaults in this building were totally destroyed.
